TECHNICAL BULLETIN		Mfg:
 	March 2009	Model:
	TB 2516	Liter:
		V I N:
		Year:

Turbocharger Failure On
2001-2009 GM 6.6L Duramax Diesel Engines

The AREA Technical Committee offers the following considerations while diagnosing turbocharger failure on 2001-09 GM 6.6L Duramax diesel engines. The engines affected are identified by engine VIN codes D, 1, 2, 6 with production codes RPOs LBZ, LB7, LLY and LMM.

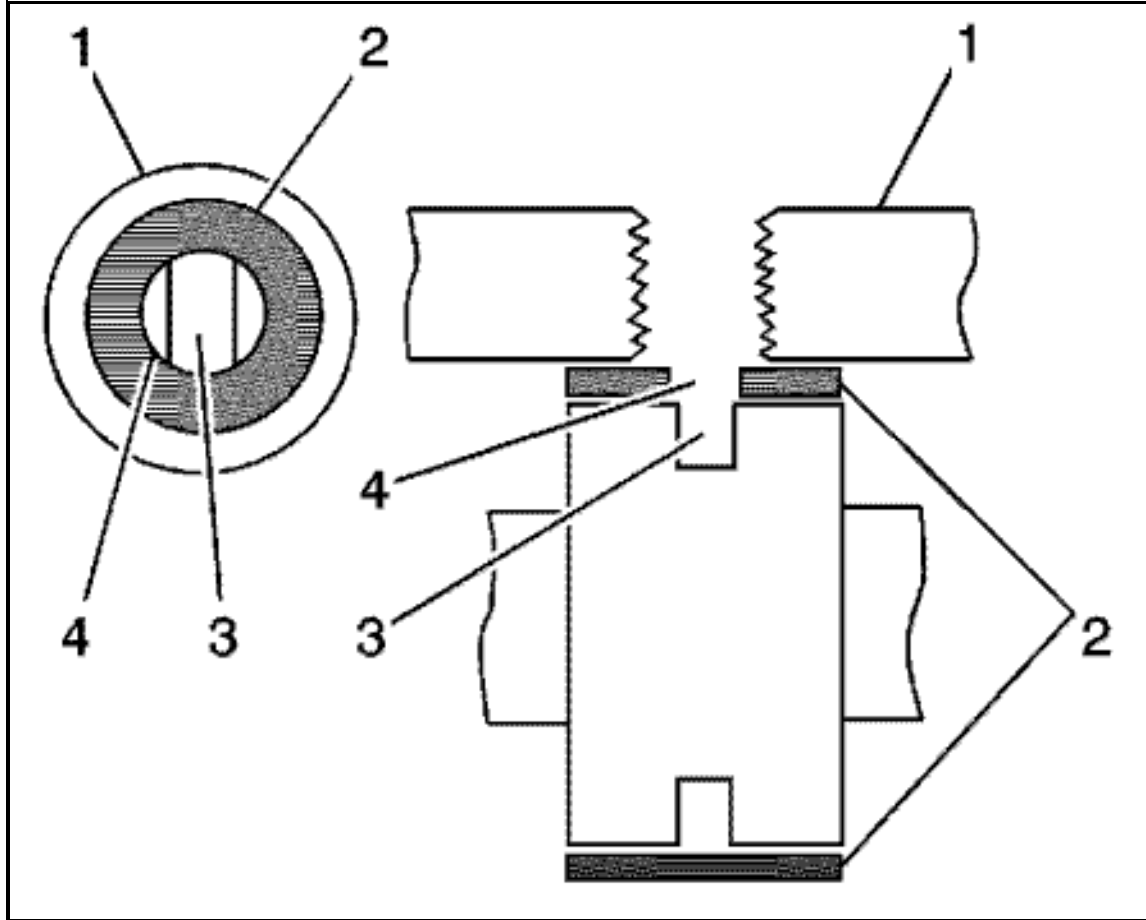
Bulletin Diagram: FIGURE 1. CAMSHAFT BEARING OIL HOLE ALIGNMENT
#4 - CYLINDER BLOCK

If a turbocharger performance concern is thought to be caused from a deficiency of engine oil, the camshaft bearing should be checked. The number 4 camshaft bearing bore feeds the turbocharger engine oil supply hose. If this camshaft bearing spins or moves in the bore, the turbocharger will be deprived of engine oil. This will cause a great performance concern with the turbocharger. Incorrect diagnosis of this condition will result in a repeat performance concern with the turbocharger.

2. Remove the turbocharger oil supply hose.
3. Visually inspect for correct alignment of the number 4 camshaft bearing oil hole (Refer to illustration callout 4) through the turbocharger oil supply hole in the block (Refer to illustration callout 1). The camshaft journal oil groove (Refer to illustration

callout 3) should be visible through the camshaft bearing oil hole (Refer to illustration callout 4).

4. Turn the engine over by hand a 1/2 turn. The camshaft journal oil groove (Refer to illustration callout 3) should still be visible through the camshaft bearing oil hole (Refer to illustration callout 4) as the engine is turned.

5. If the camshaft bearing has spun (Refer to illustration callout 2), the camshaft bearing oil hole (Refer to illustration callout 4) will either not be visible at all or it will be misaligned with the turbocharger oil supply hole during the inspection procedure. In the event of a spun camshaft bearing, the engine must be repaired.

If the turbocharger has to be replaced, perform the following procedure in order to verify the condition of the number 4 camshaft bearing before installing a new turbocharger.

1. Remove the turbocharger.
