TECHNICAL BULLETIN		Mfg: CATERPILLAR
 	December 2009	Model: C15
	TB 2526	Liter: 14.6L
		V I N:
		Year: 99-07

Lower Cylinder Block Bore Repairs For
Caterpillar 3400, C15, & C18 Diesel Engines

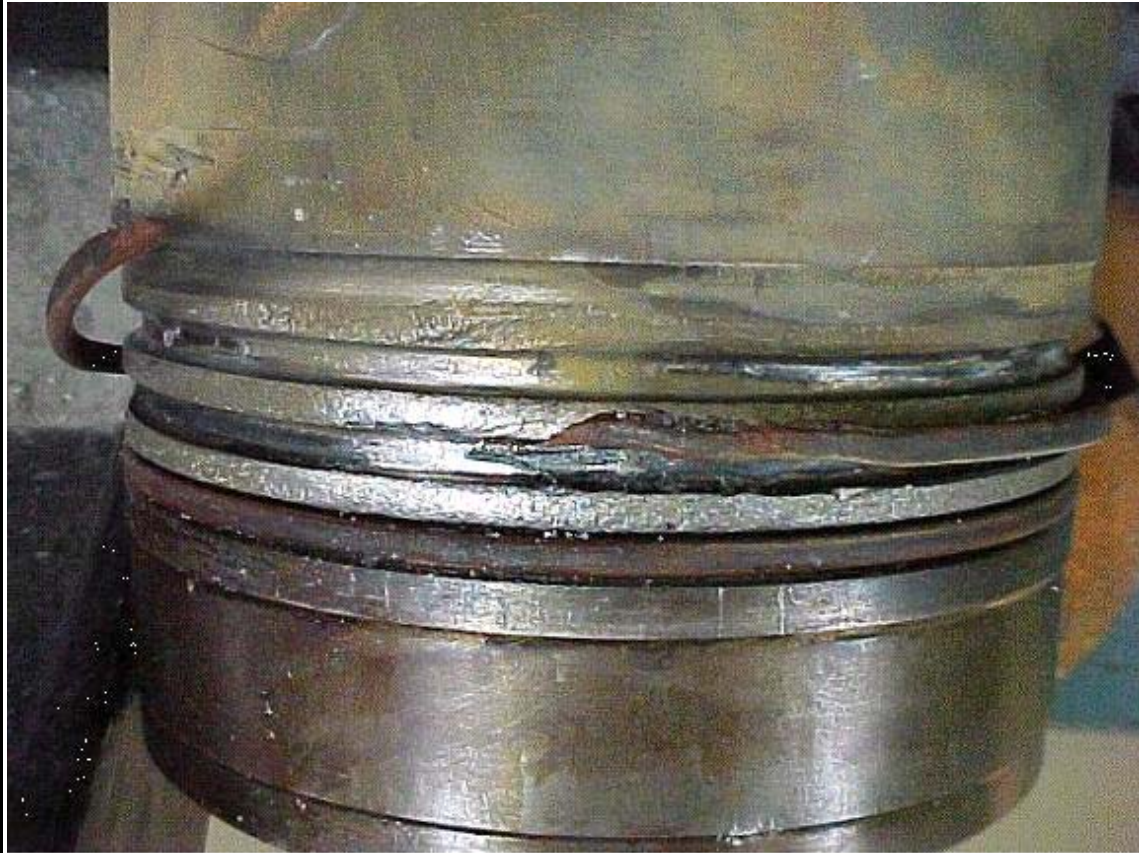
Bulletin Diagram: FIGURE 1. CYLINDER LINER DAMAGE - CYLINDER BLOCK

The AERA Technical Committee offers the following information regarding lower cylinder block repairs for Caterpillar 3400, C15 & C18 diesel engines. This information should be considered any time the cylinder liners are being serviced. The photo in Figure 1 below depicts resulting damage if the lower cylinder bores are not within specifications.

With newer engines (C Series) developing higher cylinder pressures and horsepower and older engine upgrades, the condition of lower bores becomes paramount during an engine build. Couple that with the older engines possibly having been previously built a few times before, making sure the liner is properly supported is even more important. Some engines are being upgraded from an older aluminum piston to the newer steel piston designs and this can increase the demand for performance of cylinder components as well. Clearances in the newer technology steel pistons are much tighter than those of their older aluminum predecessors, so controlling the liner movement could head off an expensive failure.

The process to repair the lower receiver bore is done with a "step" bore machining technique and a 4W6061 lower repair sleeve. To do this the cylinder block is machined to a specific oversized diameter and to a specific depth to create the proper press fit and a step in the block bore. The "Step", as shown below in Figure 2, helps retain the sleeve and creates a good seal when the sleeve bottoms out against it.
