TECHNICAL BULLETIN		Mfg: GM
 	October 2010	Model: CATERA
	TB 2544	Liter: 3.0L
		V I N: R
		Year: 97-08

Engine Noise on
2005 GM 3.0L VIN R Engines

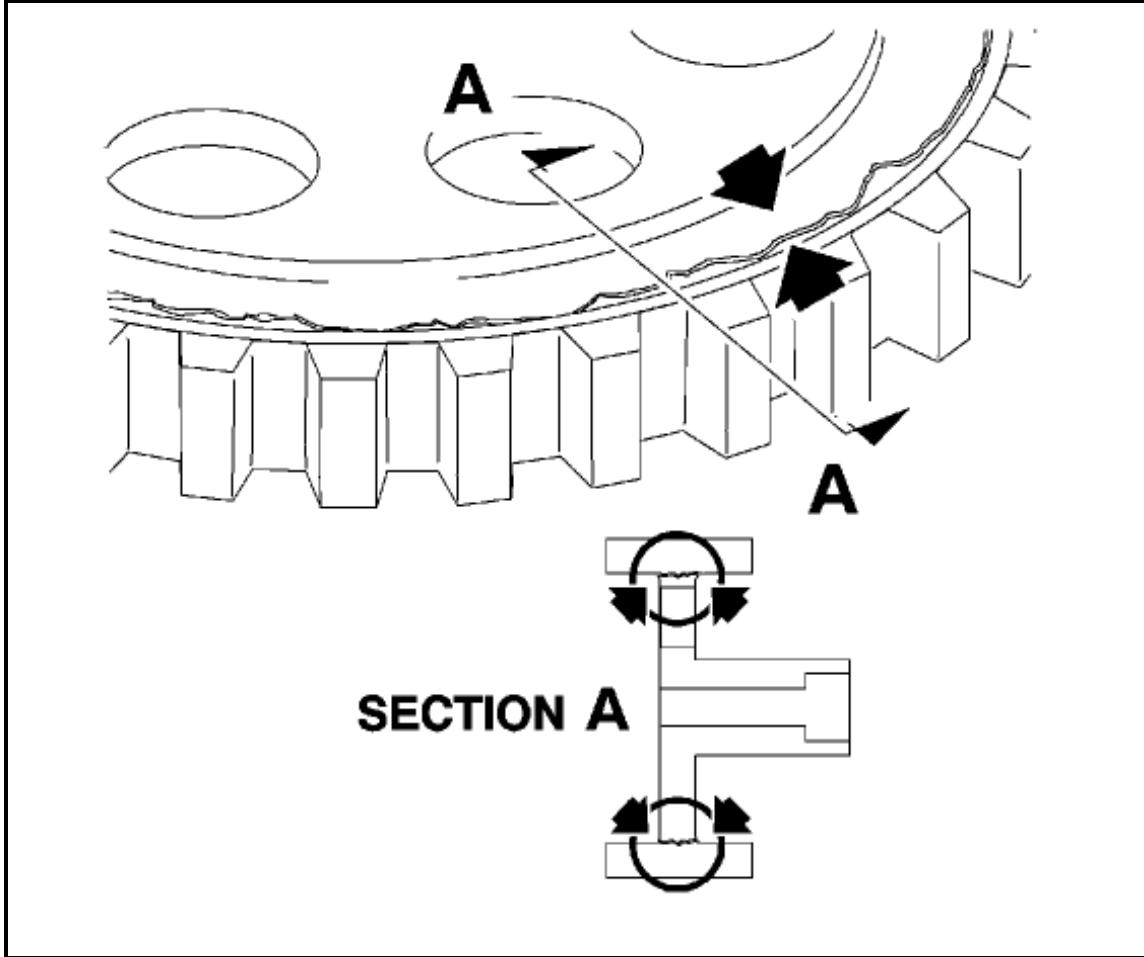
Bulletin Diagram: FIGURE 1. DAMAGED GEAR AREA - VALVE TRAIN

The cause of this condition may be caused by either of the bank 2 (front bank) timing belt camshaft sprockets being cracked near the base of the tooth area of the camshaft sprocket. Refer to the Figure 1 which shows a typical location of fatigue crack. Engines affected with this condition were built between and including VIN breakpoints 5Y501038 to 5Y505543.

Figure 1. Damaged Gear Area.

To correct this condition, it is suggested to replace both bank 2 (front bank) timing belt camshaft sprockets and bolts. The gears are available with Part #90573286 and the bolt is available with Part #90573287. When replacing the timing gears it may be necessary to renumber the gears in accordance to the gears shown in Figure 2 to assist in future timing of the gears.

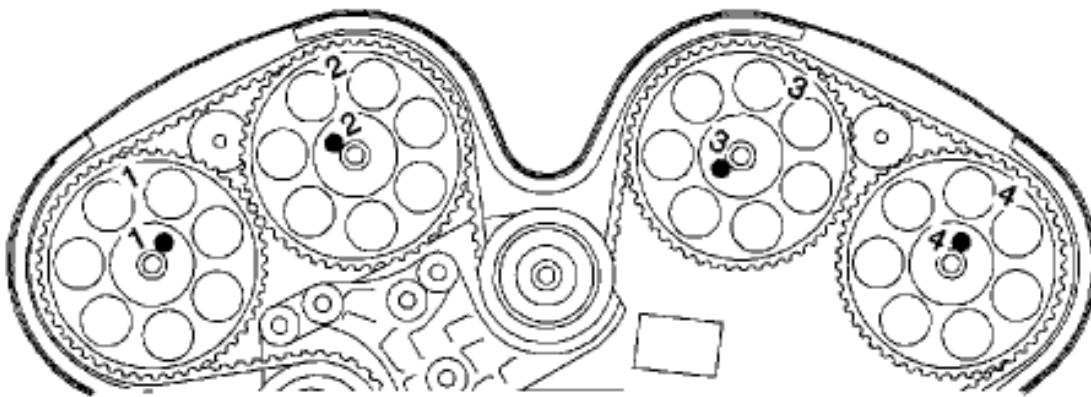
Bulletin Diagram: FIGURE 2. CAM GEAR PIN LOCATIONS - VALVE TRAIN

Figure2. Cam Gear Pin Locations

Important: Always use a new camshaft gear bolt. The required tightening method will stretch the bolts to its yield point; therefore, the bolt is not reusable. Follow the steps below to install the camshaft bolts.

1. Install the camshaft gear bolt.
2. Use the J 42069 and the J 42069-2 to hold the camshaft gear and camshaft in place while tightening the camshaft gear bolt.
3. Use the SA9140E to tighten the camshaft gear bolt. Tighten the camshaft gear

bolt to 37 ft/lbs (50 Nm) plus 60 degrees plus 15 degrees.
