TECHNICAL BULLETIN		
 	March 2011 TB 2553

Possible Engine Overheat On
1995-2004 Toyota 3.4L 5VZE Engines

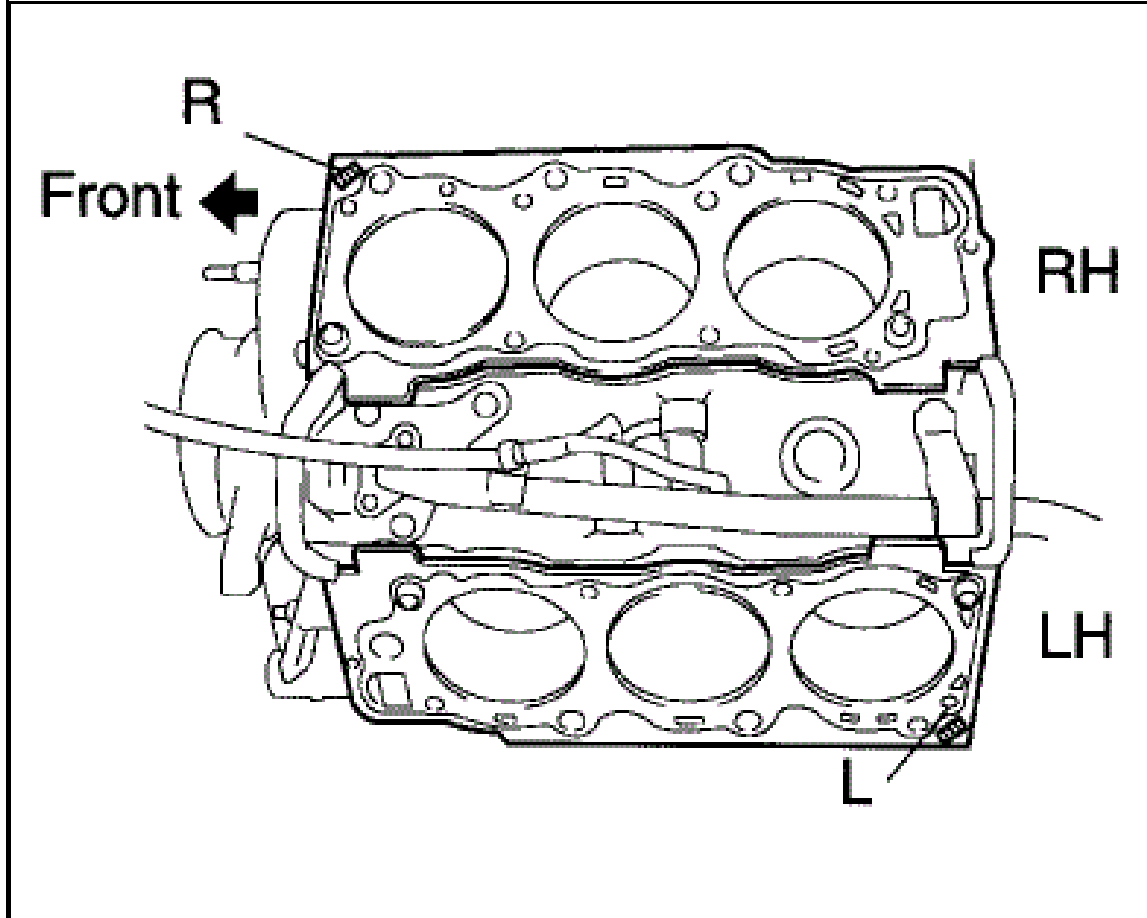
Bulletin Diagram: FIGURE 1. LEFT & RIGHT BANK GASKET LOCATIONS - CYLINDER HEAD

The head gaskets used on this engine are unique to each cylinder bank. It is, however, possible to install either gasket on the opposite bank of which it is intended to be fit. If this is done, the engine's cooling flow will be interrupted. If that occurs, eventual engine overheating may result.

The correct gasket installation shown in Figures 1 and 2 requires that the large open cooling hole is located on the left bank as viewed from the flywheel end of the engine. The right bank water passage is blocked off by the head gasket. It should also be noted that along with the head gasket differences, the heads are also location specific.

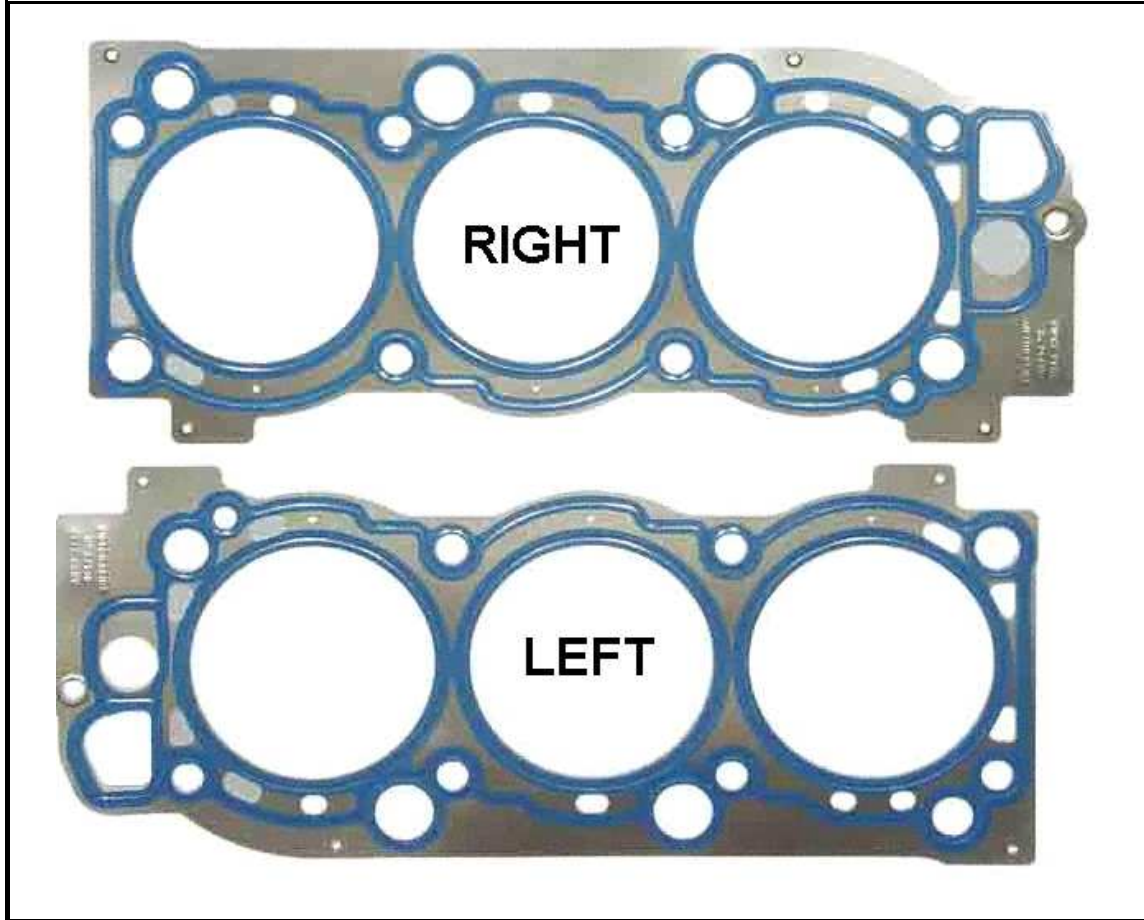
Bulletin Diagram: FIGURE 2. CORRECT LEFT & RIGHT BANK GASKET INSTALL - CYLINDER HEAD

To distinguish the different gaskets, original equipment and some aftermarket gasket companies provide identification by a raised color marking on the head gasket face. The left bank head gasket is color coded with a yellow dot and the right bank side is identified with a pink dot. Still other manufacturers' gaskets may have the letter "L" for left bank, or "R" for the right bank as viewed from the flywheel end of the engine as shown in Figure 1. Finally, some manufacturers do not distinguish their gaskets and supply only an instruction sheet for the correct installation.
