| TECHNICAL BULLETIN | | |
| | May 2011 TB 2566 | |

Cylinder Head Damage On
2003-09 Mazda 2.0L Engines

The AERA Technical Committee offers the following information regarding cylinder head damage on 2003-2009 Mazda 2.0L engines. The damage related to this bulletin may be resulting from previous engine noises heard prior to the driver's complaints. If previous repairs have been performed, the vehicle owner may want to contact Mazda directly for possible reimbursement.

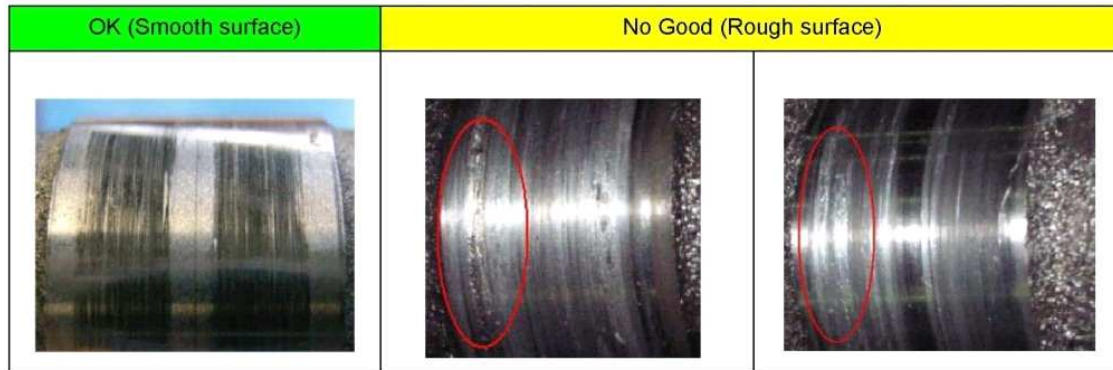
Bulletin Diagram: FIGURE 4. CAMSHAFT LOBE SURFACE COMPARISON - FAILURE ANALYSIS

Check for any visual damage to the camshaft and journals. Camshaft surface should be smooth.

Figure 3: Camshaft Failure

If no good, contact Mazda for authorization to replace cylinder head assembly and camshafts. Refer to Figure 3 for camshaft failure pictures.
