TECHNICAL BULLETIN		
 	May 2011 TB 2579

Oil Control Valve (OCV) Inspection On
2003-08 Hyundai 1.6, 2.0, 2.4, 2.7, 3.3, 3.8 & 4.6L Engines

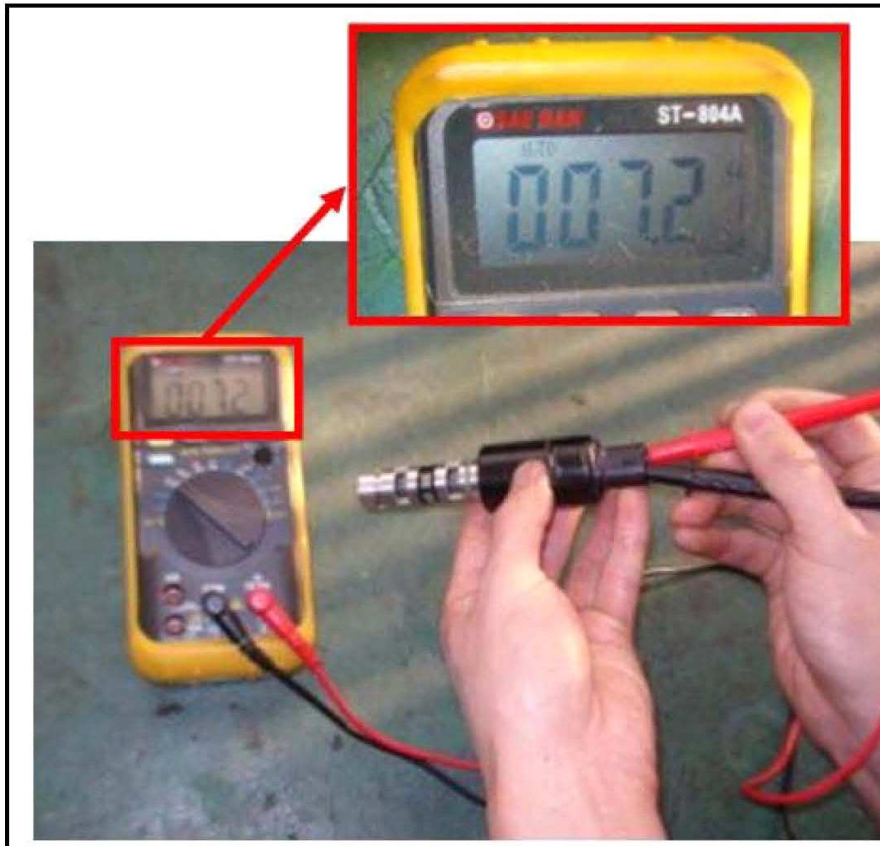
Bulletin Diagram: FIGURE 2. TESTING OCV WITH OHM METER - FAILURE ANALYSIS

To check the OCV, measure the resistance between OCV power and signal terminals as shown in Figure 2. Refer to the Figure 3 chart for ranges and OCV supplier specs.

Figure 2: Testing OCV

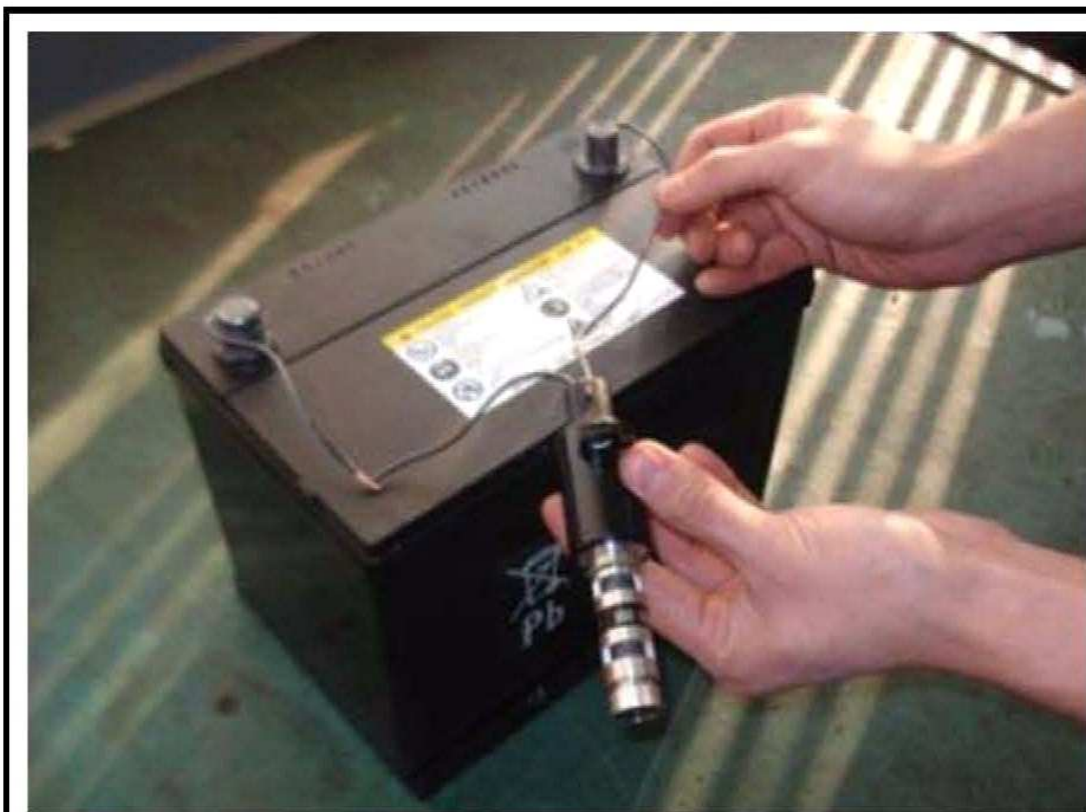
Bulletin Diagram: FIGURE 4. CHECKING OCV OPERATION WITH 12 VOLTS - FAILURE ANALYSIS

Check to make sure that the OCV operates normally by providing 12V power as shown in Figure 4.

Figure 4: Checking operation using 12V.

Careful attention is necessary to avoid a short circuit when providing the OCV with 12V power. Spacing between the OCV power and the signal terminals is very narrow. Use suitable connections to prevent shorting of the test power supply.

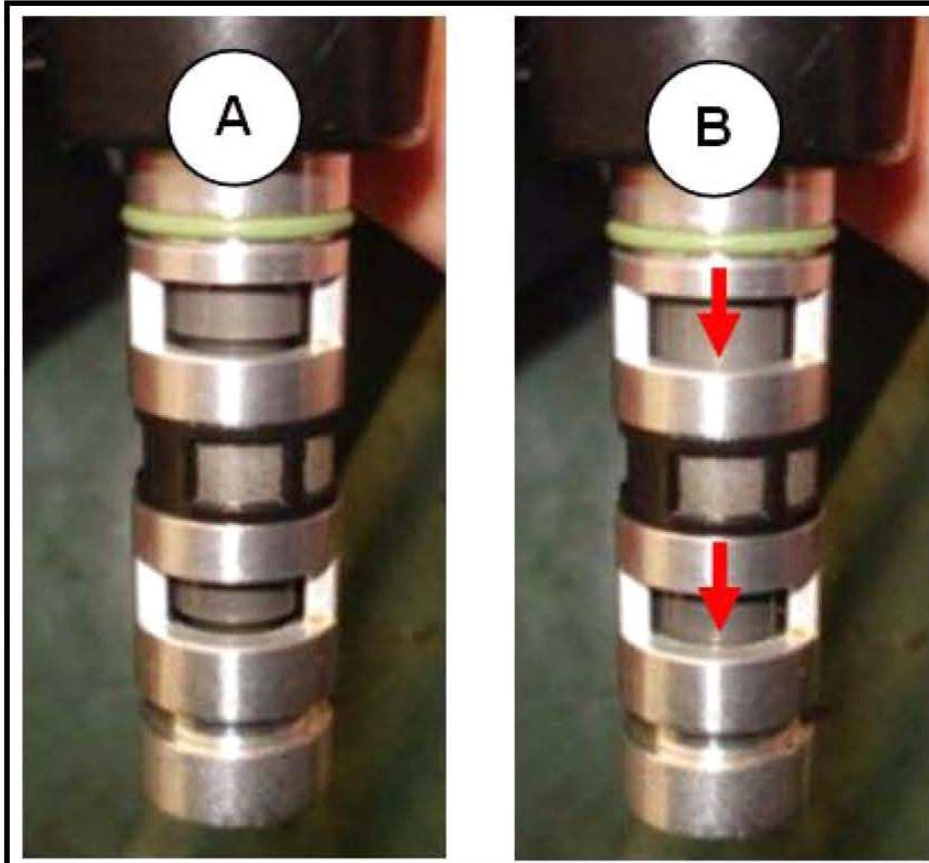
Bulletin Diagram: FIGURE 5. OCV MOVEMENT - FAILURE ANALYSIS

When 12V power is provided to the OCV, the OCV must move forward as shown in the Figure 5. Picture A shows maximum retarded valve timing condition when 12V not provided. Picture B shows advanced valve timing condition with 12V supplied. NOTE: Reverse the connection polarity if the movement is opposite.

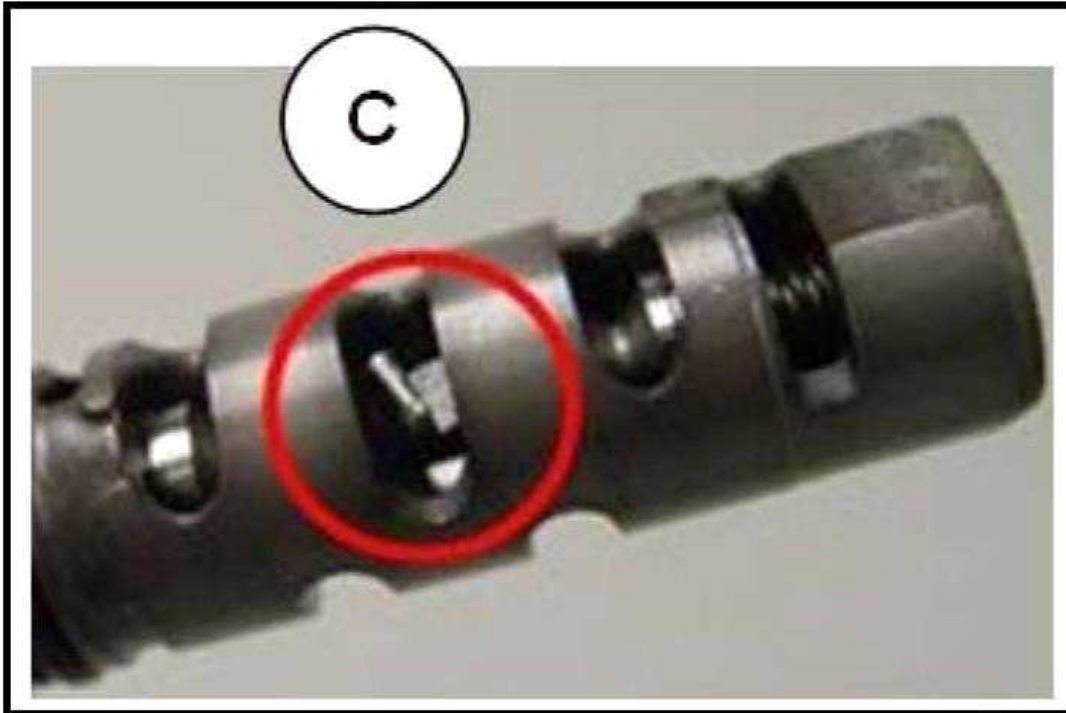
Bulletin Diagram: FIGURE 6. ALUMINUM DEBRI JAMMED IN OCV - FAILURE ANALYSIS

Figure 5: OCV movement Figure 6: Aluminum chip jammed in OCV

If the OCV does not move forward, examine it for a foreign object such as an aluminum chip © is jammed inside the OCV as show in Figure 6. Blow out the foreign object using compressed air, reinstall the OCV and then verify that the fault is corrected.
