TECHNICAL BULLETIN		Mfg: CUMMINS
 	December 2003 TB 2125	Model: L10
		Liter: 10.0L
		V I N:
		Year: 85-90

Cam Bearing Bore Repair For
Cummins 1985-2003 L10 & M11 Engines

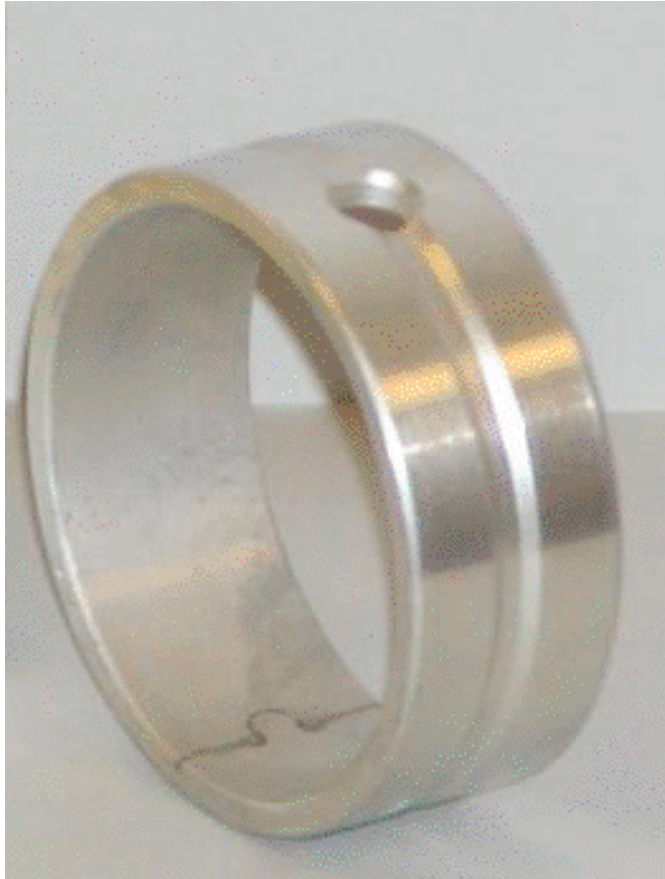
Bulletin Diagram: FIGURE 1, OVERSIZE CAM BEARING - CYLINDER BLOCK

These engines have been prone to engine failure related to cam bearing movement during engine operation. The cam bores generally were enlarged to a degree that sleeve installation in the affected bore was required. The standard cam bearing was then pressed back into the bore, in effect putting a sleeve inside a sleeve. In many instances, that process did not make a long lasting repair as many engines suffered subsequent failures. This new .170" (4.3 mm) wall thickness bearing combines both processes into one and should allow a reliable repair for many otherwise discarded blocks.

This bearing combines the thickness of the Cummins supplied repair sleeve Part #3824894 and standard cam bearing Part # 3820566 into one component. This bearing has almost twice as much wall thickness as the standard cam bearing.

To install this bearing, first determine a .0020-.0025" interference fit before align boring the camshaft housing bore. This bushing Part # MCB7025 is currently available from one aftermarket supplier. Please contact AERA Technical Services at 1/888-324-2372 for an update on aftermarket suppliers of this type bearing.
