TECHNICAL BULLETIN		
 	November 2000 TB 1841

Blast Media Cleaning Caution

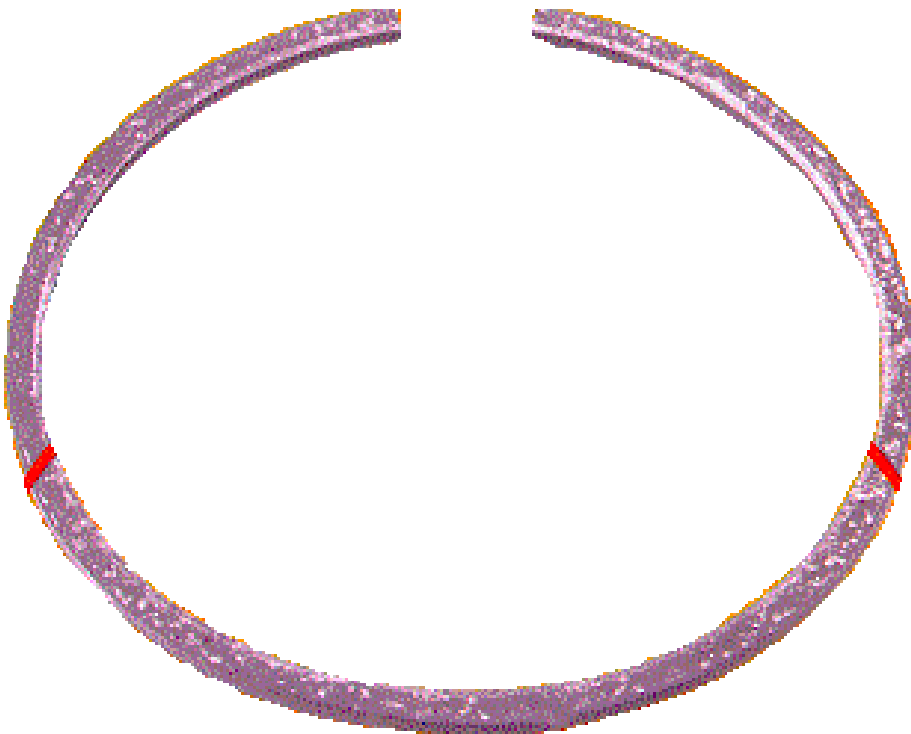
Bulletin Diagram: DAMAGED PISTON RING - CYLINDER BLOCK

Reports of media contaminated and damaged piston rings have been reported by a piston ring manufacturer. This media was found in the “washed parts absolute filter” at their lab and it was later determined to be coming from the engine builders’ component rinse tanks. As displayed below the media has produced a “pitted” appearance on the ring top and bottom surfaces.

Any residual media and/or fragments that are deposited and remain within a block/head/engine component will be detrimental to engine life. How the harmful material is transported or attaches itself can sometimes be overlooked. Airborne, harmful “dust” may migrate anywhere, depending on air movement. Another form of contamination has been residual magnification of components that were previously magnetic particle inspected. Fine metallic particles that remain attached to cast iron components after rinsing may be washed off later by engine oil and cause engine damage.

Bead and grit blast cleaning can be a highly cost effective and efficient method of cleaning engine parts such as blocks, heads, and manifolds. These engine components, however, have many internal passages with irregular surfaces. Many areas include blind ends and are virtually inaccessible to mechanical cleaning methods. If glass bead or grit blasting is used to clean components, it is imperative a method of cleaning the castings is employed which removes all the cleaning media from the internal passages. Even a microscopic amount of certain cleaning media left in an oil or intake passage may be ingested by the engine and severe damage to all engine parts will result.

Sodium bicarbonate (Baking Soda) has recently been introduced as a cleaning media for blasting machines; it dissolves in water during the final water rinse cleaning of engine components.
